**LABORATORY REPORT  
ON  
AIRBORNE SOUND TRANSMISSION-LOSS MEASUREMENTS  
OF  
THE SAC 11 C29 DOOR SET  
FOR  
SUPA RICH CO., LTD.  
THAILAND.**

**Test panel:** *SAC 11 C29* door set.

**Client:** SUPA RICH Co., Ltd.

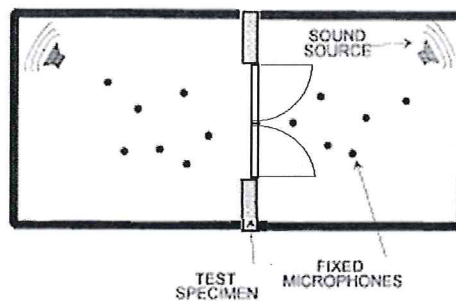
**Figure 3.** Schematic drawing of the measurement set-up in a double-reverberation chamber.

Before the transmission-loss measurement, the microphone calibration was done and the background noise was measured. Then, the pink noise was sent to the loudspeaker unit, which placed in the source room. There are two microphones used in this measurement. One was installed in the source room to record the incident sound pressure level on the specimen before transmit through the material. Another microphone was placed in the receiving room to measure the transmitted sound pressure level and the reverberation time of the receiving room.
