**LABORATORY REPORT  
ON  
AIRBORNE SOUND TRANSMISSION-LOSS MEASUREMENTS  
OF  
THE SAC 11 C34 DOOR SET  
FOR  
SUPA RICH CO., LTD.  
THAILAND.**

Laboratory measurement of the airborne sound transmission loss (TL) of the Acoustic wooden door set model “*SAC 11 C34*” submitted by SUPA RICH Co., Ltd. on 20 November 2021.

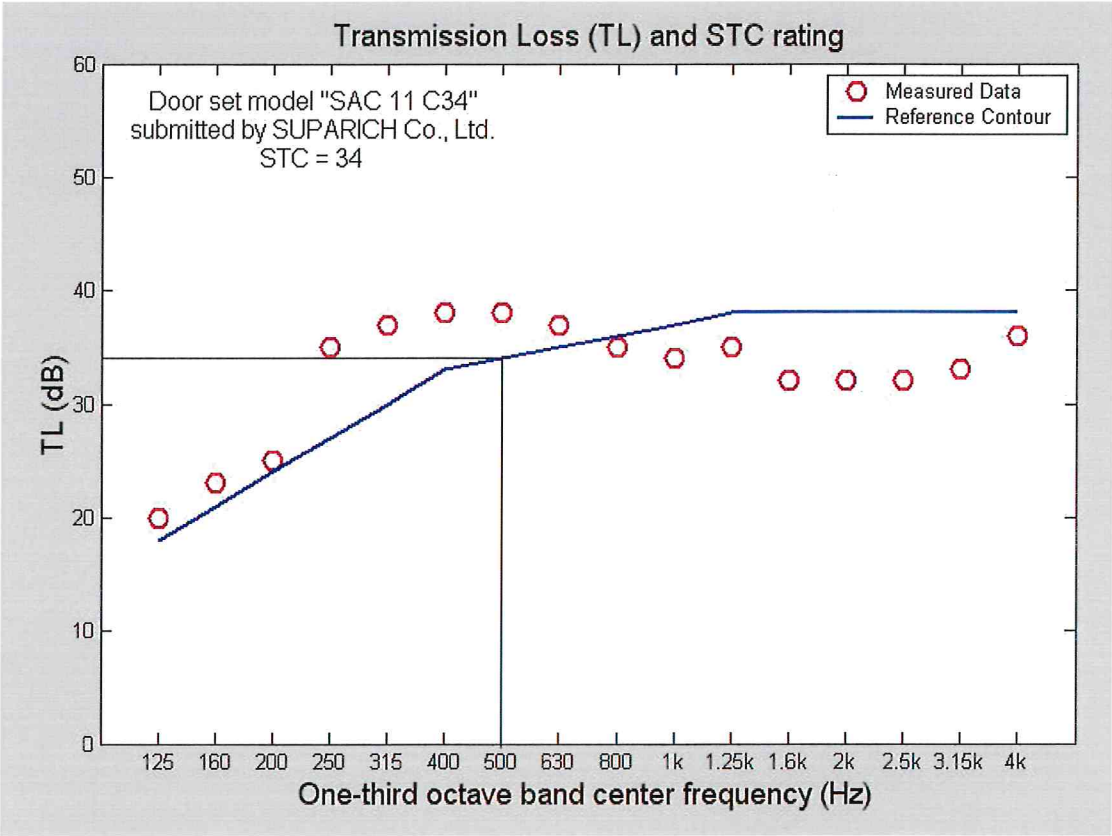
Figure 1. The airborne sound transmission-loss (TL) and the STC rating of the test sample.

The airborne sound transmission-loss (TL) of the test sample for each individual 1/3 octave band center frequency and the STC rating number of the test wall were tabulated in **Table 1**. The graphical representation of the values in the table 1 was shown in **figure 1**.

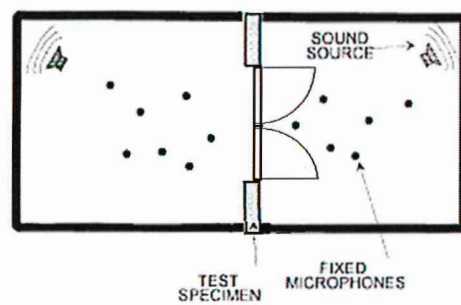
**Figure 3.** Schematic drawing of the measurement set-up in a double-reverberation chamber.

The specimens were installed between two reverberation chambers, as illustrated in Figure 3.

To determine the airborne sound transmission loss (TL), the specimen was installed between two reverberation chambers (see Figure 3). The space- and time-averaged sound pressure levels in the two rooms are determined. In addition, with the test specimen in place, the sound absorption in the receiving room is determined. The sound pressure levels in the two rooms, the sound absorption in the receiving room and the area of the specimen are used to calculate transmission loss (TL) value. And the Sound transmission class (STC) is determined.
